Manhole Inspection Summary

Manhole # S29AA1016MH

Insp Date: **12/13/06 9:30 AM**

Location Address: **3427 CHESTNUT AVE**

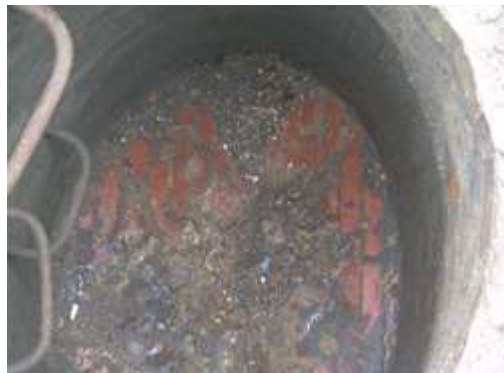
Top View

Corroded steps. Channel debris.

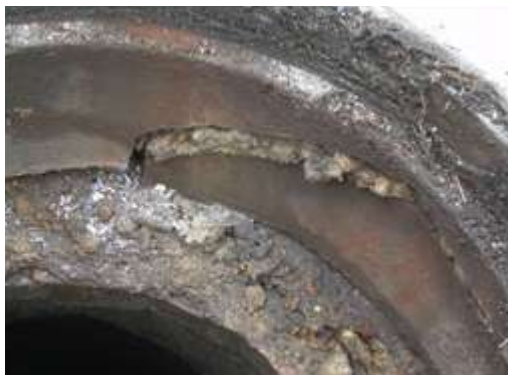
Defect

Frame leaks. Cracked frame. Frame offset. Corbel infiltration.

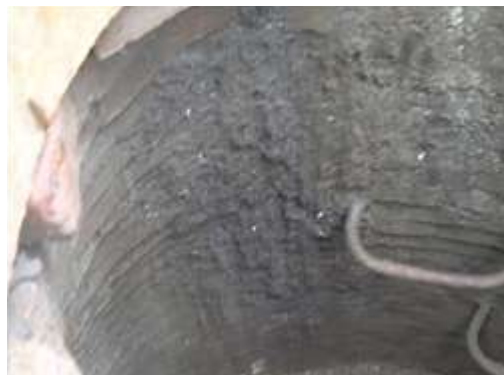
Defect

Frame leaks. Corbel deterioration, loose brick and infiltration.

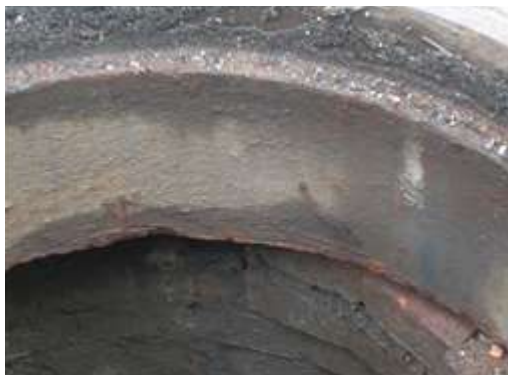
Defect

Frame leaks. Corbel deterioration and infiltration.

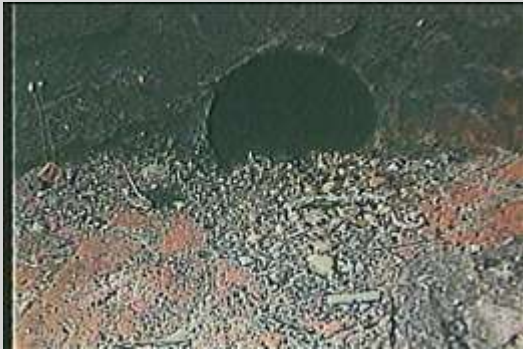
8 in. Circular Gravity Sewer
Pipe Out @ 12 O'Clock

Deposits: ☐ None ☒ **Mud** ☐ Sludge ☒ **Debris** ☐ Grease

Silt Depth: **1** (in.) Deposits Extent: **Light**
